2013
Civil
Engineering
Category

WINNER

The Radiographic Cell

POOLE

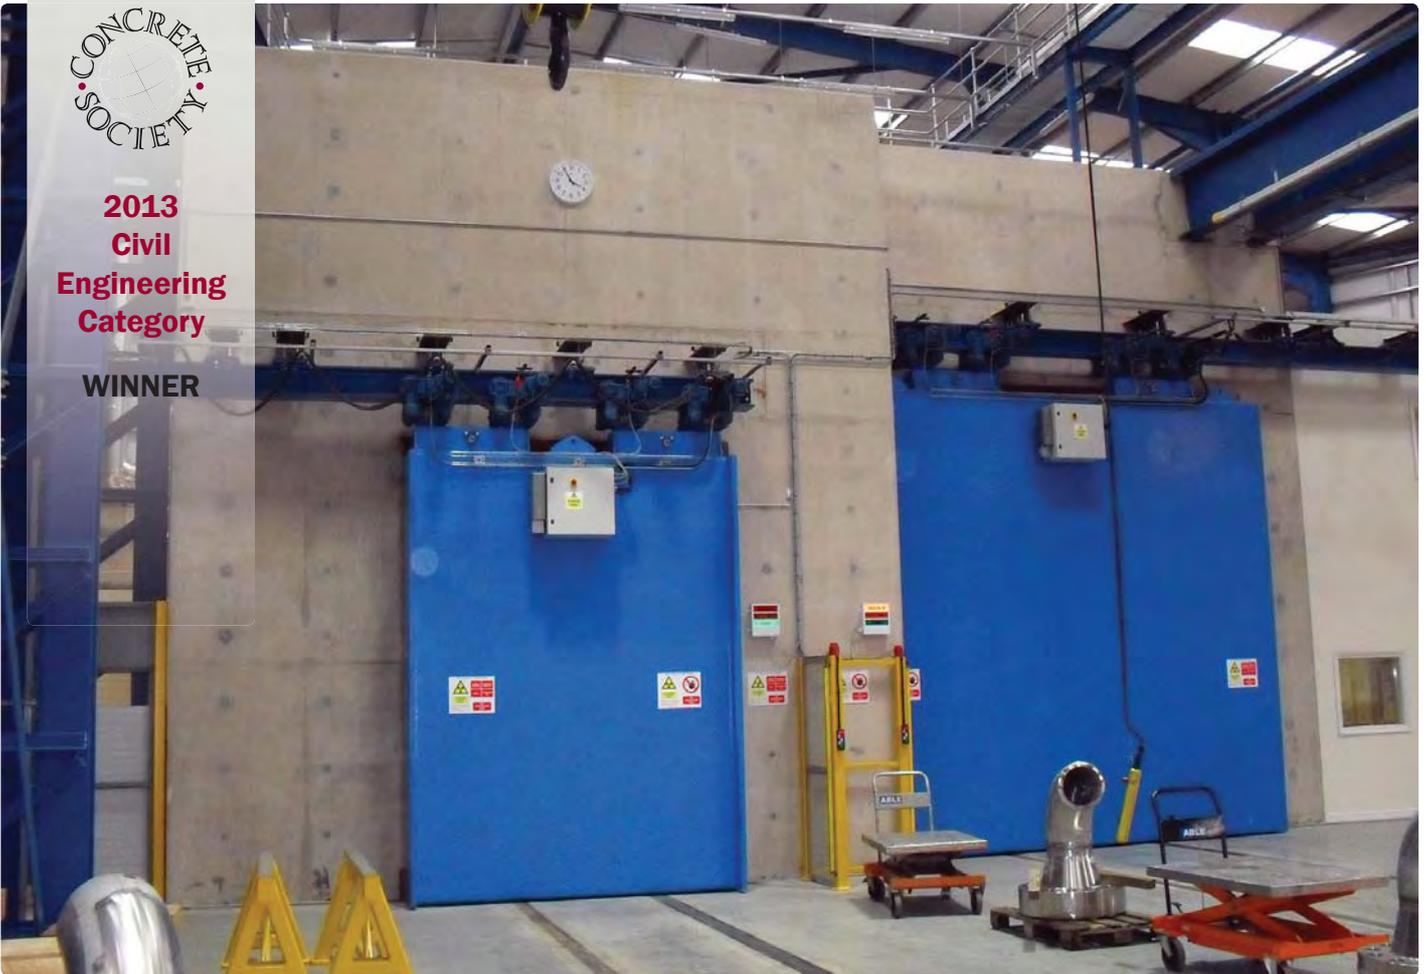
Above: Finished structure showing a 40-tonne door hung within a 1–2mm verticality tolerance.

A high standard of workmanship is evident in the finish achieved. Despite the high GGBS content there were very few 'sand runs' and none of any significance. Formwork tolerance around the 40 tonne doors was very tight as the 'seal' closure is part of the X-ray containment.

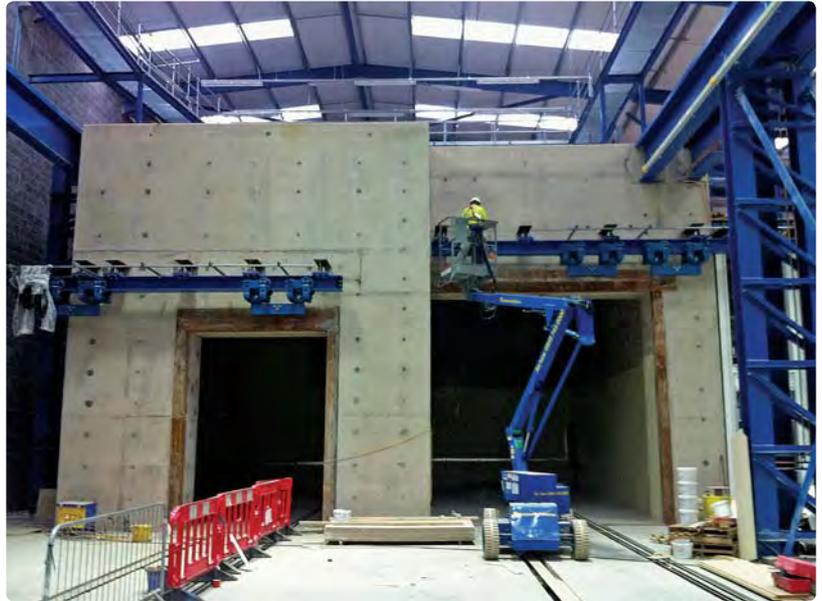
Above: Structure completely stripped, door steelwork in place ready for hanging the 40-tonne doors.

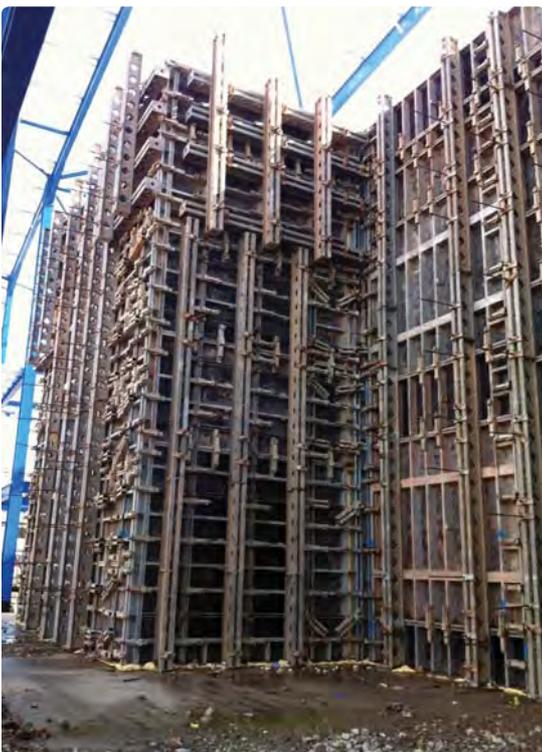
Far left: All formwork in place prior to the external sheeted enclosure placement.

As well as controlling the concrete temperatures with a designed mix, specialist formwork was required as a secondary measure. This was achieved by insulating the faces of all the formwork with a 25mm-thick high compressive strength insulating board between the formwork pan and the ply. This meant that the temperature differential between the core and the face could be limited to a maximum of 20°C.

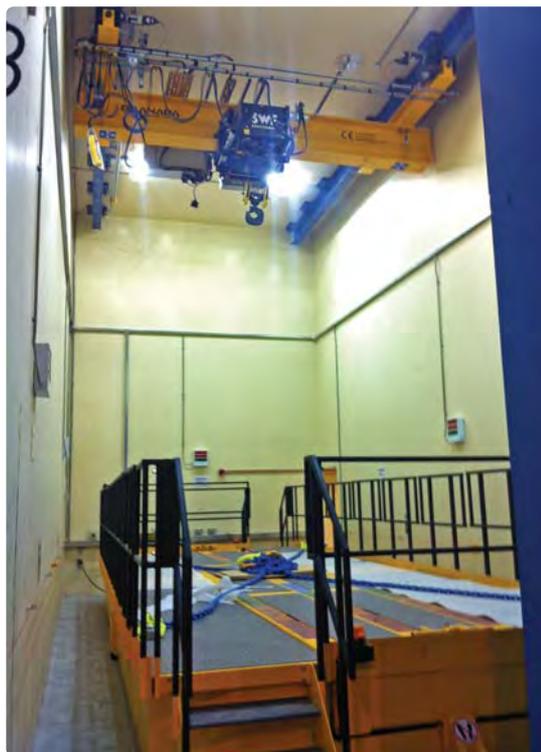
Left: Internal view of Cell A, showing the cast-in crane beams within the top of the cell.

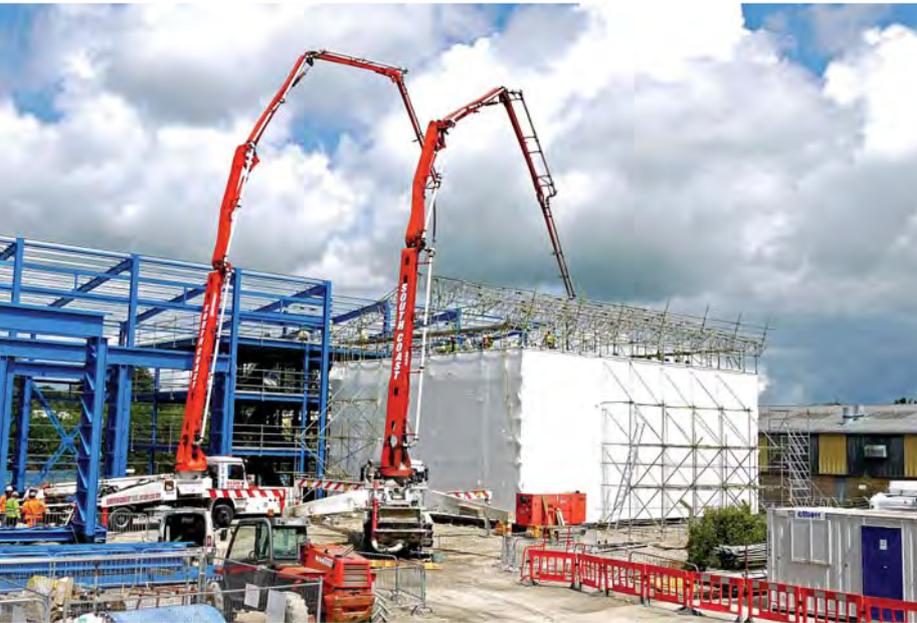
Above: External sheeting in place prior to pouring and the final sheet installation.

Due to the problems with such a tight specification in respect of controlling the differential temperatures, the decision was made to provide an enclosure scaffold around the entire cell, covered with shrink-wrap plastic. A heating specialist was employed to install

an automated heating system to ensure that the temperature within the enclosure and internally within the cell would not drop below 20°C at any time. In line with the continual monitoring of the temperatures, the temperature of the cell was also regulated during the day with real-time data from the data logger system and if necessary the enclosure was opened up to reduce the internal heat.

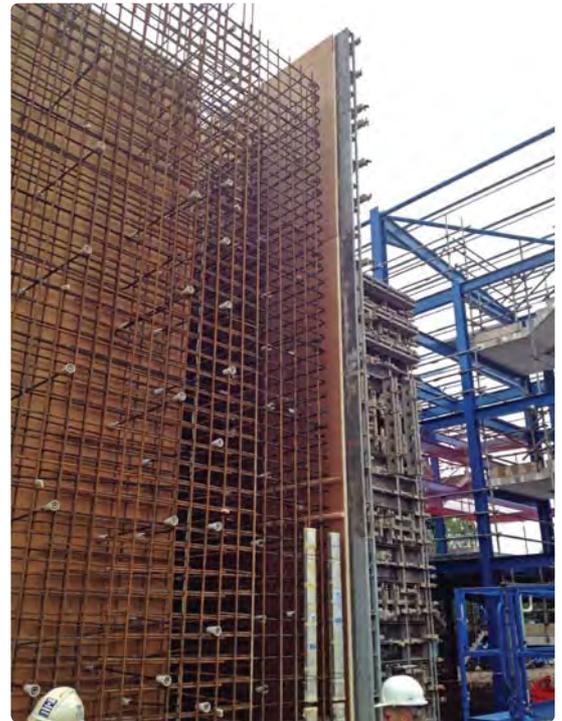
Above: Wall reinforcement being fixed in position.
